Defect reduction and particle control in localized Track

KINGSEMI

2020.11

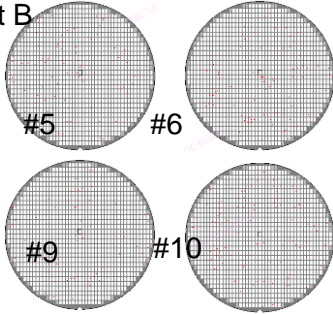
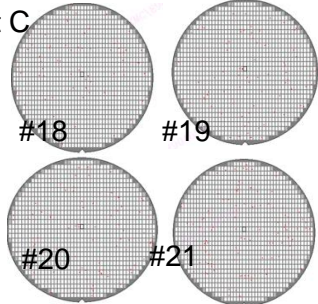
IP5X SDC2 DEV defect performance in consist 3 days

A	Unit	<u>KDEV (New recipe)</u>		
Base line Total defect : ~96	Day	23-Apr-20	28-Apr-20	30-Apr-20
	Defect Map	Lot A

#18 #19 #20 #21
	Defect count	93	104/105/83/136	90/98/102/131
	Defect Spec	Total Defect ~ 100ea within consistent 3 days		
	Conclusion	Pass the defect verification ✓

- Defect Type : Resist Residue on resist .
- Action 1.DI rinse : change to agitation DI rinse
- Action 2.Remove Spin Dry before 2nd Develop dispense
- Result : defect count : 93ea (Base line 96ea) ,
- Spec 100ea . (Done)

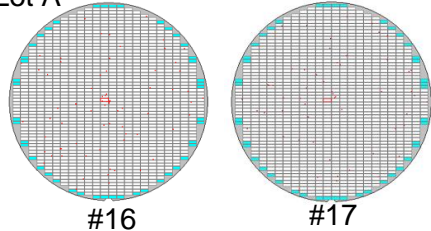
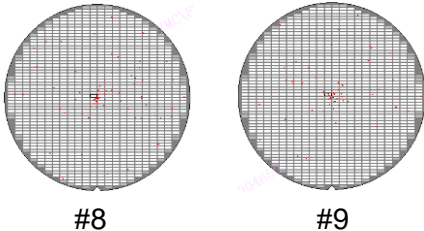
Product	Unit	KDEV (Optimized recipe)		
J Base line Total defect : ~60	Day	21-Apr-20	22-Apr-20	23-Apr
	Defect Map	Lot A

#8 #9
	Defect count	81 / 59	95 / 74 / 86 / 65	88 / 82
	Defect Spec	Total Defect < 100ea within consistent 3 days		
	Conclusion	Pass the verification ✓

- Defect Type : Resist Residue in exposed region .
- Action 1: Add DI rinse 2sec after DI puddle
- Action 2 :change to agitation DI rinse
- Action 3.Remove Spin Dry after 1st rinse
- Result : defect count : 59 ea (Base line ~60ea) , Spec 100 . (Done)

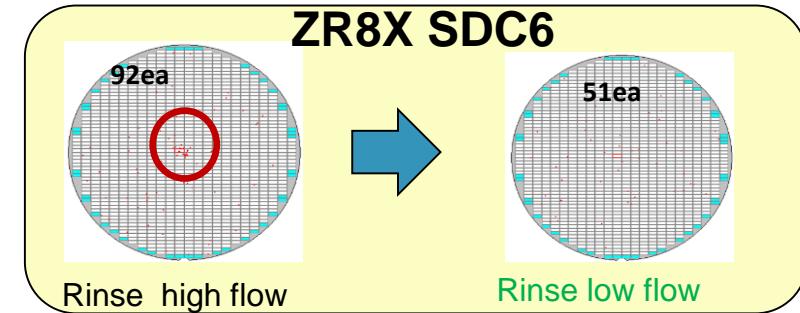
1. ZR8X multiple chamber defect verification

- Defect Type :multi chamber **Center defect cluster**.
- **Action :reduced Rinse flow**
- Result : no center cluster
- Status : pass chamber matching verification ✓

Conclusion	SDC2-6 chamber shows that wafer center has a cluster of defect, belonging to special map, and it must be solved

SDC center problem solving process (in SDC6 unit)							
ZR8X	J (005)	chan ges	None	Rinse center left shift 5mm	Rinse center right shift 2mm	Rinse DIW2-DIW3 scan , distance between D2 and D3 5mm	Reduce Rinse flow rate,
	Base line Total defec t : ~100	Defe ct Map					
	concl usion	1.At present, there is no jig to judge the center of wafer , removing the Rinse off center and adding scan in recipe can reduce the center cluster to some extent 2.Reducing the rinse flow rate can solve the center problem, because in this way, flow rate and spin speed can have a better combination to give a better cleaning effect

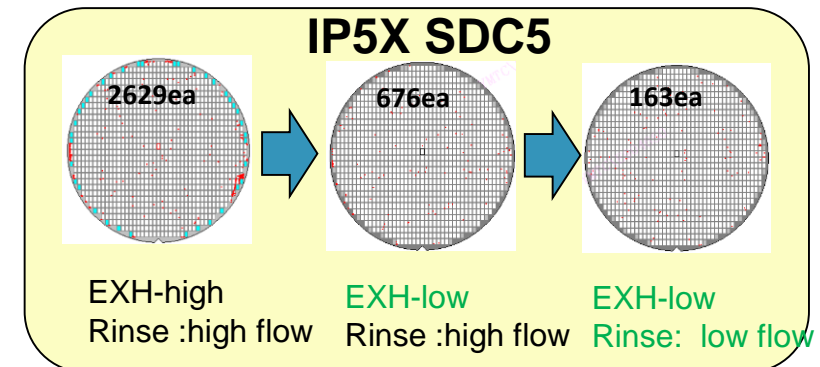
2. IP5X multi chamber defect verification

- Defect Type : **SDC5 cluster defect** in non-exposure area
- **Action 1.adjust SDC5 EXH change**
- **Action 2. reduced Rinse flow rate,**
- Result : solve SDC5 edge cluster
- Status : pass chamber matching verification ✓

Concl usion	SDC5 Unit shows that wafer edge has much defect in unexposed area, and this situation is mainly fixed in SDC5, but never happened in SDC2 with the same recipe, so compare the hardware differences between different units

conclusion	Defect in edge is related to EXH and Rinse flow.

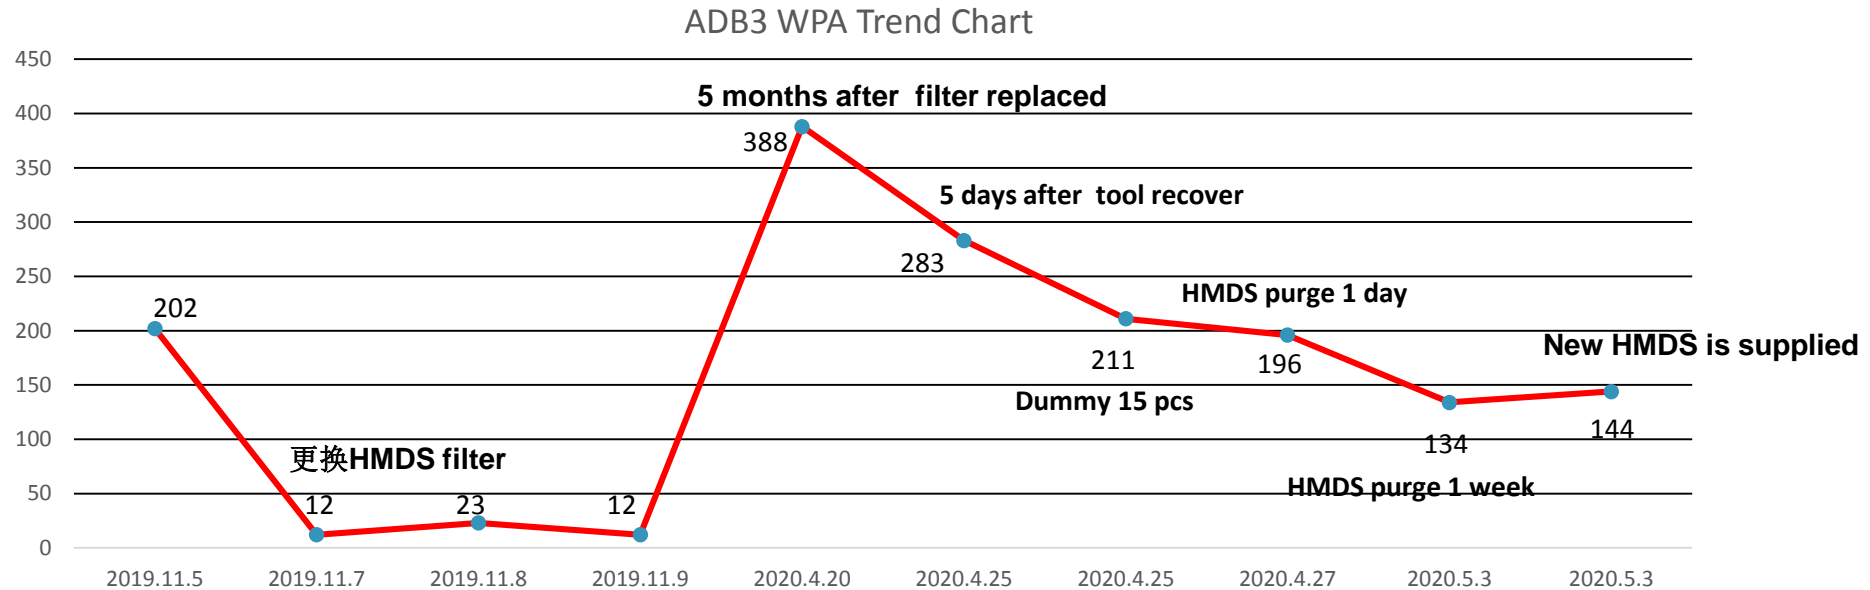
ADB3 HMDS WPA trend chart

1. After filter replacement , WPA trend down . After 1 week , WPA trend up again. It mean, the pipe line or HMDS tank contain particle.

2. Pipe accounts for only 50 in total AD WPA of about 300, and it can be eliminated through N2 purge

3. AD contamination is not from outdated HMDS, because after new liquid is supplied, no change in its WPA

Possible cause : Long idle cause chemical crystal result contamination in the TANK .

1. HMDS suffered high wet Particle .
 - **Direct cause :** HMDS tank long idle , the remaining chemical soak in tank too long . HMDS gel generated and induce the particle after evaporation .
 - **Root cause :** HMDS Tank design weakness .
 1. HMDS HH to H to L sensor distance is too long , result fresh HMDS can't be refilled on time.
 2. tank have big capacity , long width and height , HMDS top up slowly .
 3. HMDS supply without temperature control .

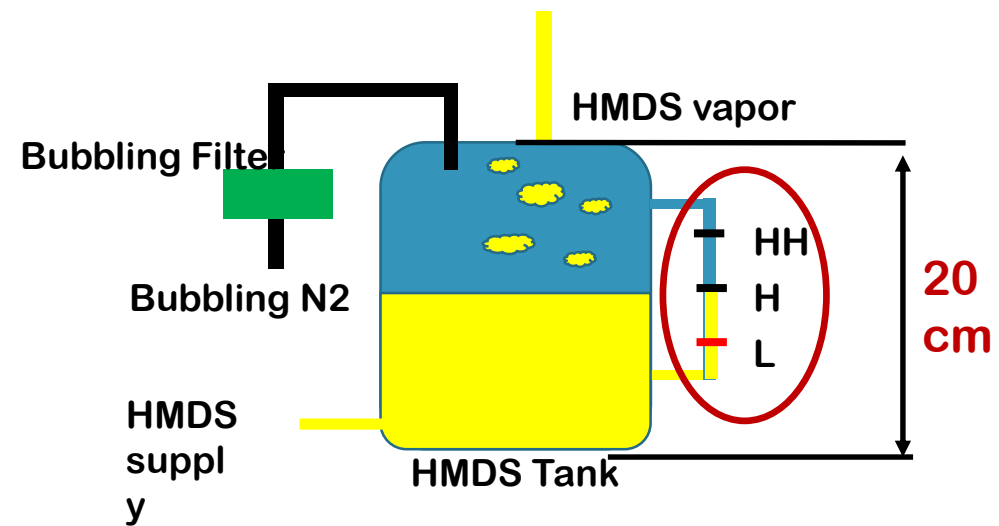
K ADH chamber old Structure :

Height of Tank	Liquid level sensor	HMDS supply pipe
New HMDS TANK	10mm	in tank	with heat preservation
old HMDS TANK	20mm	out of tank	Without heat preservation
conclusion	1.HMDS is a kind of chemical that is easy to volatile and crystallize between liquid and solid 2.New tank can effectively avoid the volatilization and crystallization of HMDS

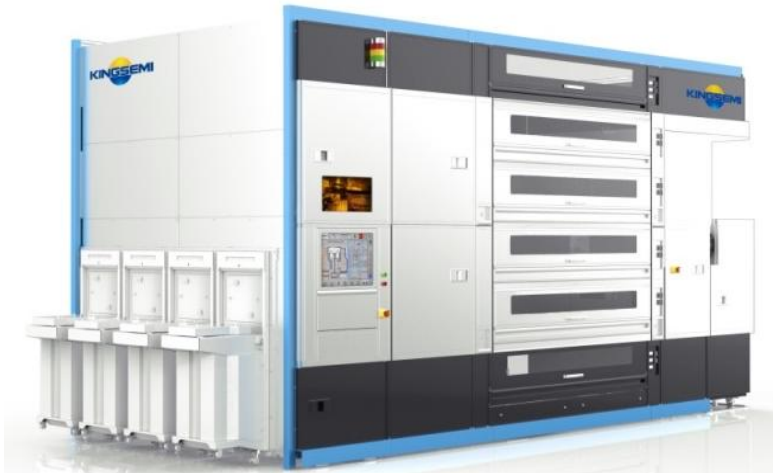
Front Track KS-FT300

- Low Particle wafer Transfer system
- Improved overall equipment efficiency (OEE) for litho cells
- Reduced Cost of Owner (CoO) 、 Cost of Consumables (CoC)
- **Throughput: ≥ 240 WPH , Inline or offline**

- **DUV、 I-line lithography、 Barc 、 PI Coating**
- Spin-on carbon、 dielectrics、 glass
- 200mm and 300mm wafers

- **Multiple chambers, flexible configuration according to customer requirements**
